## METROPOLITAN COAL

### LONGWALLS 311-316

### BIODIVERSITY MANAGEMENT PLAN

October 2025

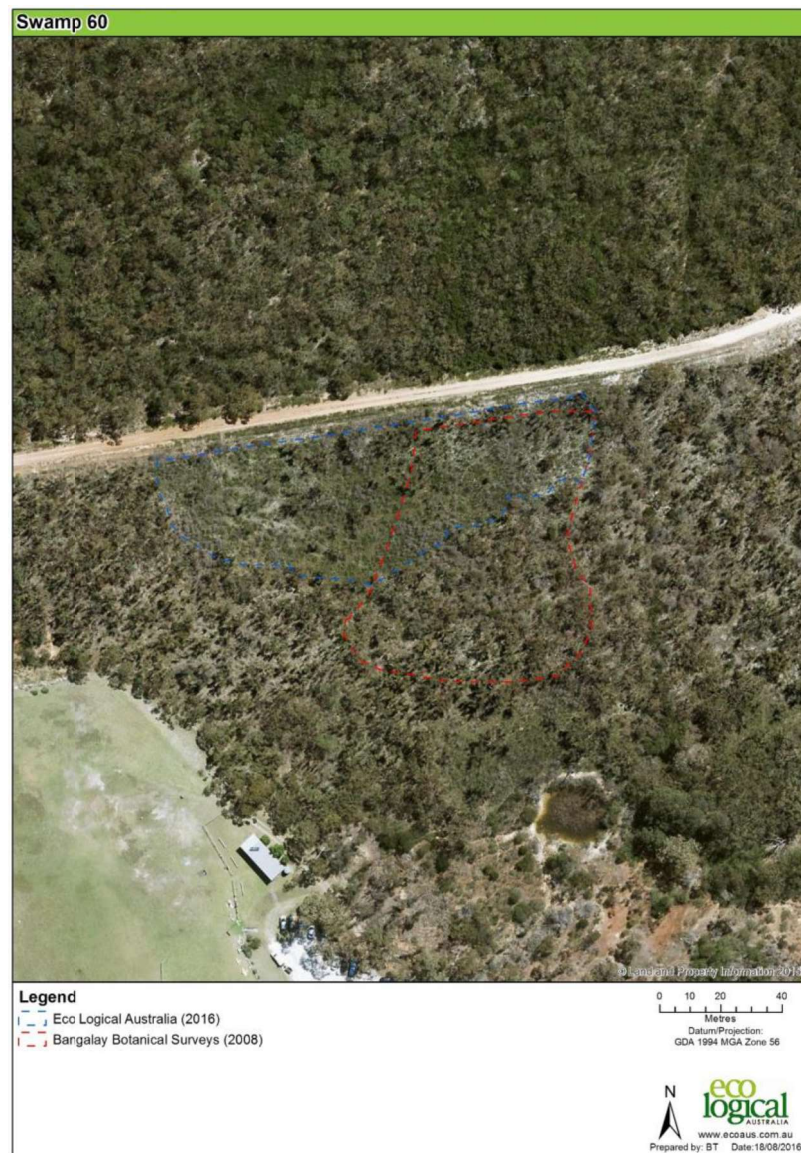
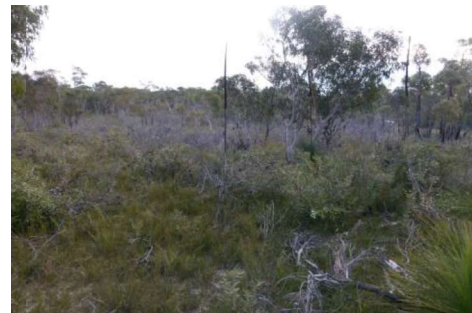
## Swamp 60

- Swamp 60 is a valley side swamp.
- Swamp 60 was previously mapped as Sedgeland-heath Complex by Bangalay Botanical Surveys (2008) and field inspections confirmed the presence of this community across the entire revised extent of this swamp.

- No terminal step or seepage was observed within this swamp, although soils were saturated at the time of inspection.

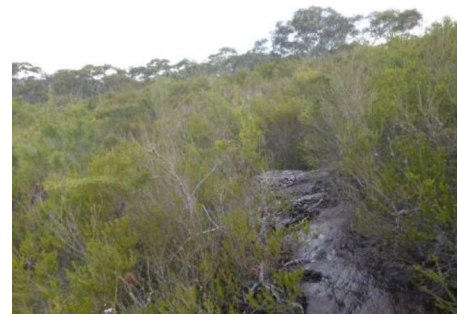
## Swamp 81

- Swamp 81 is a valley side swamp approximately 0.728 ha in area.
- This swamp was previously mapped as Sedgeland-heath Complex by Bangalay Botanical Surveys (2008) though field inspections confirmed the presence of Banksia Thicket vegetation community across the entire revised extent of this swamp.
- Fire history: burnt 1986-1987 and 1993-1994.
- This swamp is characterised as having a tall dense shrub layer (*Banksia ericifolia* subsp. *ericifolia* and *Leptospermum squarrosum* 2-3 m in height) over an understorey dominated by sedges (*Chordifex fastigiatus*, *Lepidosperma filiforme* and *L. neesii*).
- No terminal step was observed but an extensive mid-swamp step is present, with abundant seepage present.

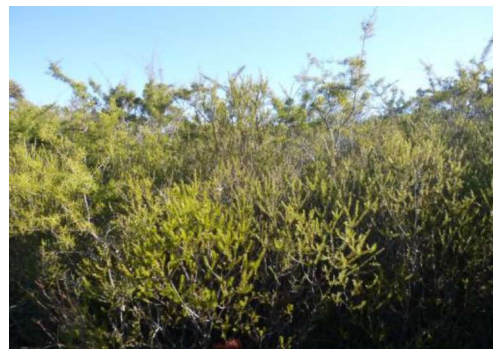
## Swamp 82

- Swamp 82 is a valley side swamp approximately 1.437 ha in area.
- This swamp was previously mapped as Sedgeland-heath Complex by Bangalay Botanical Surveys (2008) though field inspections confirmed the presence of Banksia Thicket vegetation community across the entire revised extent of this swamp.

- An intermittent area of outcropping sandstone/terminal step is present at the lower end of this swamp, below which a woodland community was present.
- A drainage line is present within the swamp, which flows out across part of the terminal step.

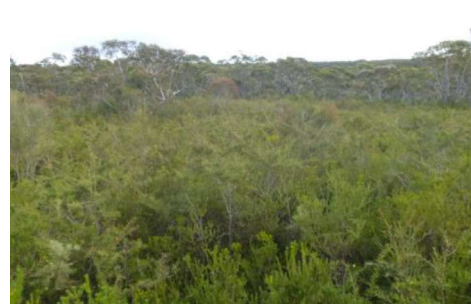
## Swamp 83

- Swamp 83 is a valley side swamp 0.202 ha in area.
- This swamp was previously mapped as Sedgeland-heath Complex by Bangalay Botanical Surveys (2008) though field inspections confirmed the presence of Banksia Thicket vegetation community across the entire revised extent of this swamp.

- No terminal step of outcropping sandstone was observed, however outcropping sandstone was present within the swamp.

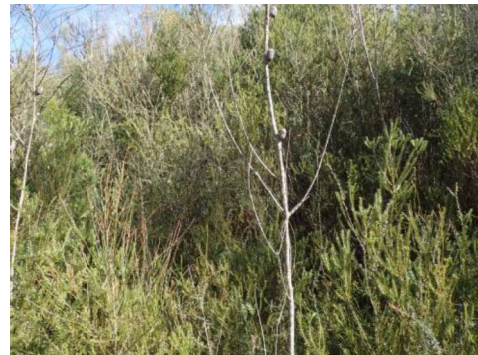
## Swamp 88

- Swamp 88 is a valley side swamp 0.164 ha in area.
- This swamp was previously mapped as Sedgeland-heath Complex by Bangalay Botanical Surveys (2008) though field inspections confirmed the presence of Banksia Thicket vegetation community across the entire revised extent of this swamp.
- Fire history: burnt 1993-1994.
- This swamp is characterised as having a tall dense shrub layer of *Banksia ericifolia* subsp. *ericifolia*, *Leptospermum squarrosum* and scattered *Hakea teretifolia* up to 4.5 m in height over a comparatively dense understorey dominated by sedges (*Empodisma minus*, *Chordifex dimorphus* and *Leptocarpus tenax*).
- A low sandstone step is present midway through the swamp.

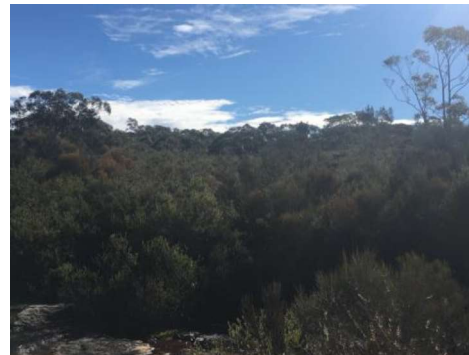
## Swamp 89

- Swamp 89 is a valley side swamp 1.983 ha in area.
- This swamp was previously mapped as Sedgeland-heath Complex by Bangalay Botanical Surveys (2008) though field inspections confirmed the presence of Banksia Thicket vegetation community across the entire revised extent of this swamp.

- An extensive area of sandstone outcropping is present along the south-eastern edge of this swamp where seepage and water flow exiting from the swamp was observed.

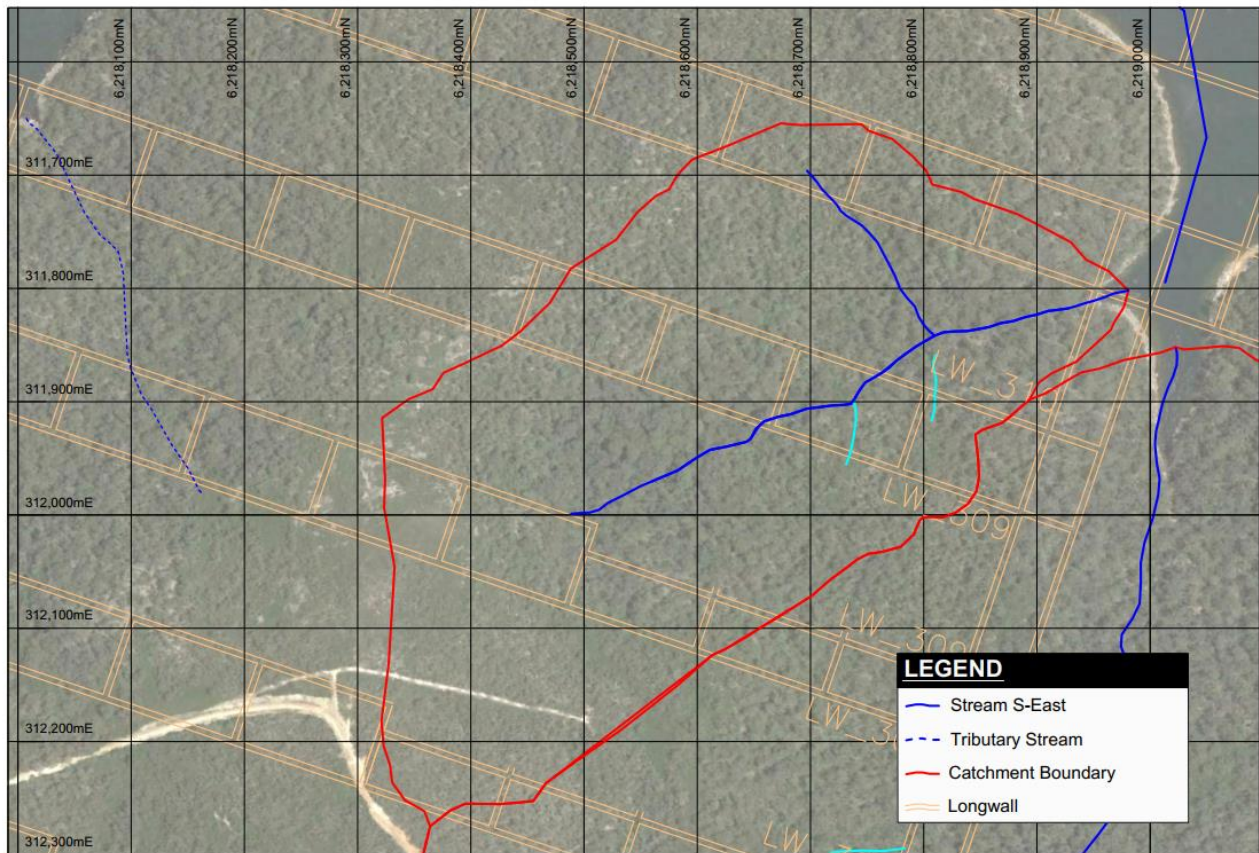
**Figure 15 Stream S-East Catchment**

Stream S-East is joined by a small stream which flowed through a confined valley – refer Figure 15. The upper sections comprised a steep, gully form with ill-defined drainage channels and boulder cascades. Several pools were observed in the lower reaches with two medium pools near the confluence of the two arms of the stream. There was no significant flow observed and no visible flow at either the stream confluence or at the outflow to the Woronora Reservoir.

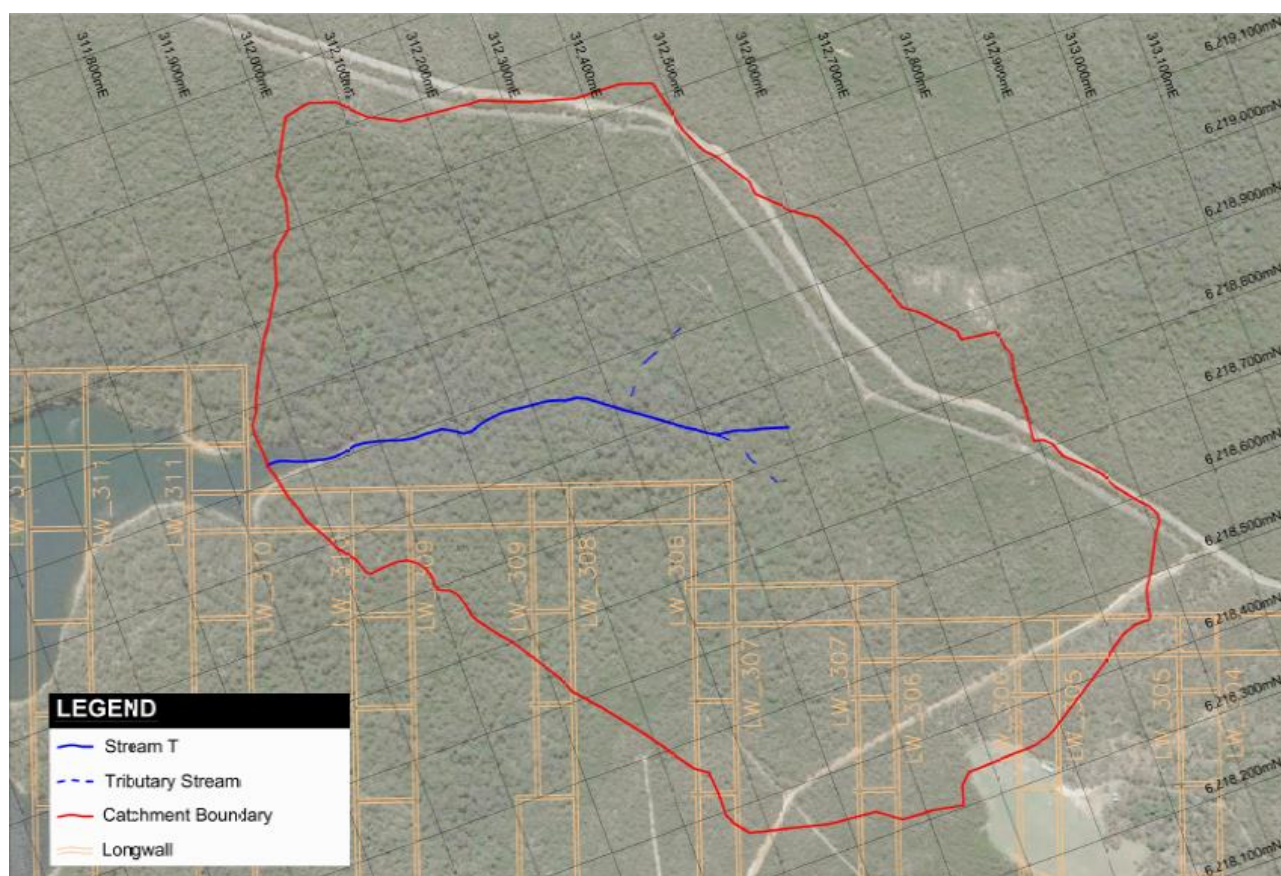
**Figure 17 Stream T Catchment**

Stream T is a small second order stream – refer Figure 17. The stream morphology is similar to Stream S-East. There was a small continuous flow in the lower reaches of the stream which carried through to the Woronora Reservoir. The medium and larger pools mapped were larger than those observed in Stream S-East.

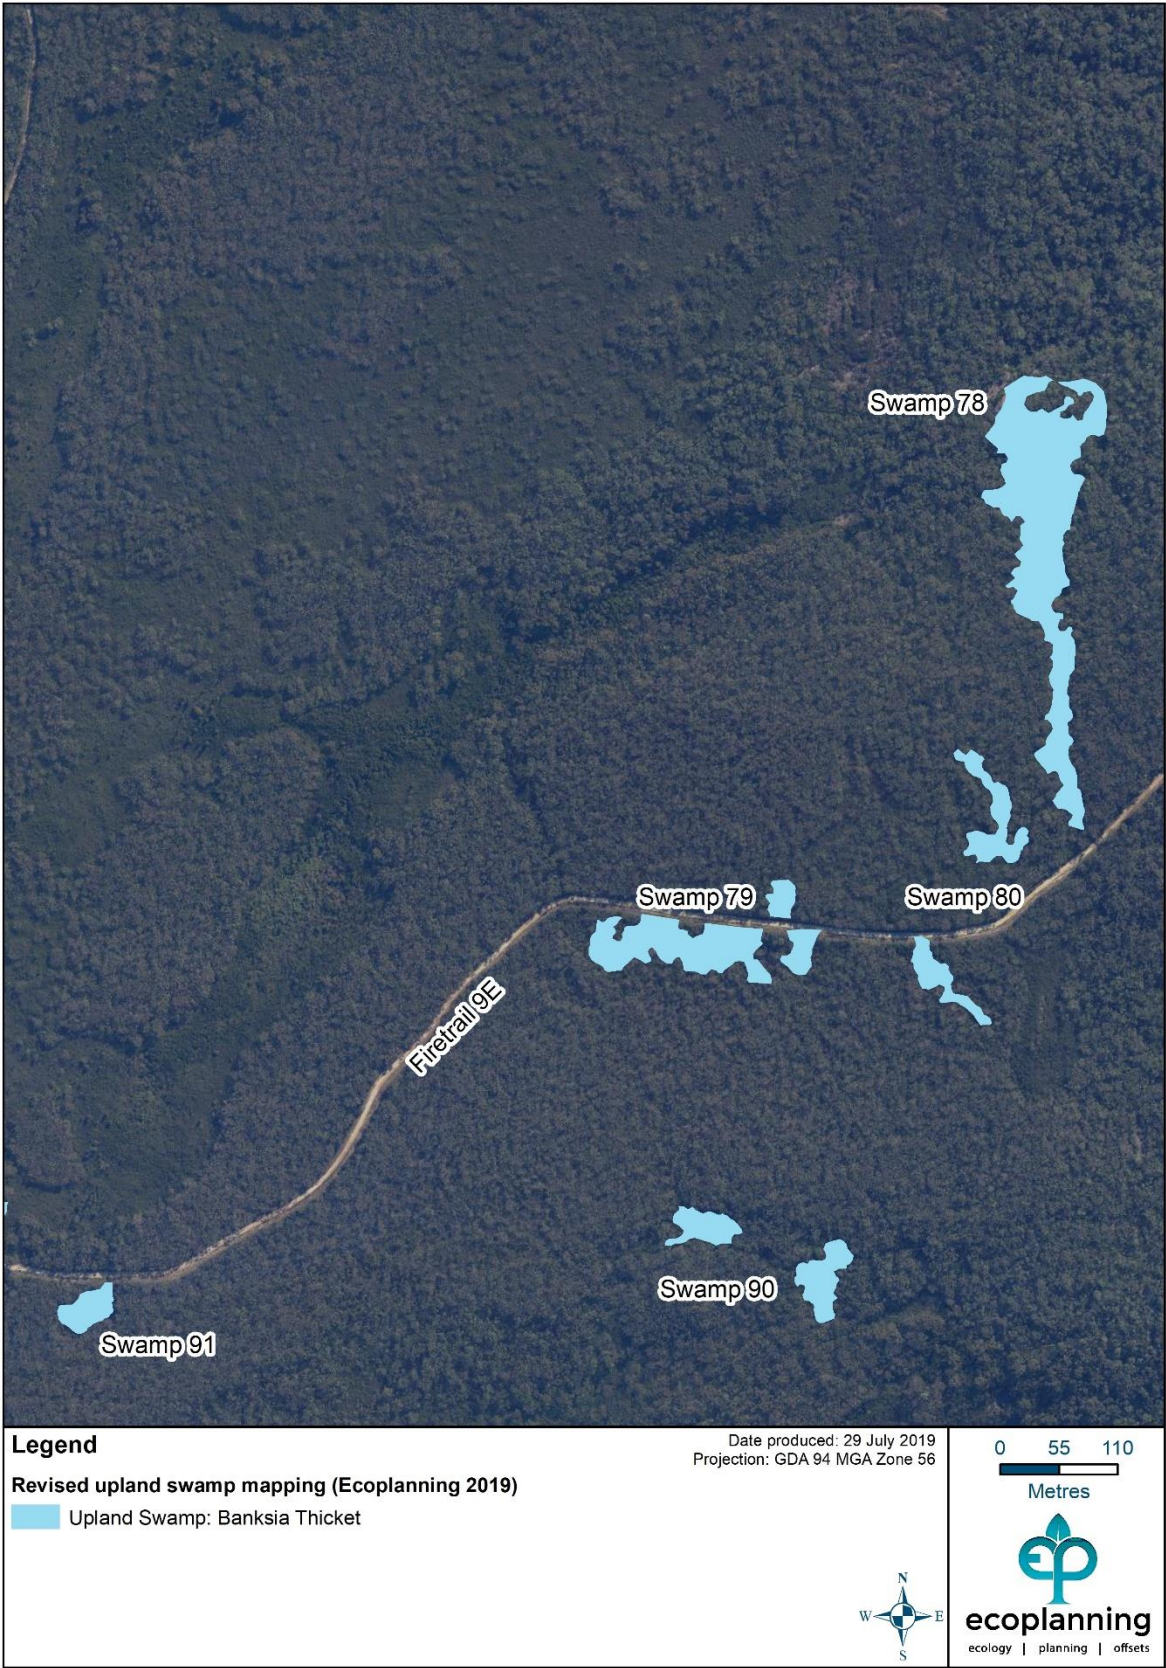
Figure 3.1: Revised upland swamp vegetation mapping extent (Ecoplanning 2019)

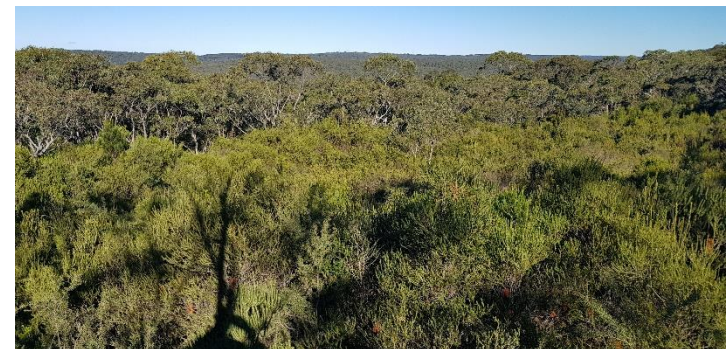
## Swamp 90

- Swamp 90 is a small east-west curved swamp located in part over Longwalls 311 and 312 and over the Longwall 311-312 chain pillar.
- This swamp was previously mapped as Sedgeland-heath Complex (BBS 2008). Field inspections identified that the extent of swamp vegetation is much reduced and located in two separate areas herein referred to as Swamp 90a and Swamp 90b located to the east of Swamp 90a. The vegetation across Swamp 90a and 90b conforms to Banksia Thicket with the adjoining vegetation identified as Sandstone Heath Woodland. Both areas are located south of Fire Trail 9E.

- Both Swamps 90a and 90b lack a terminal step.

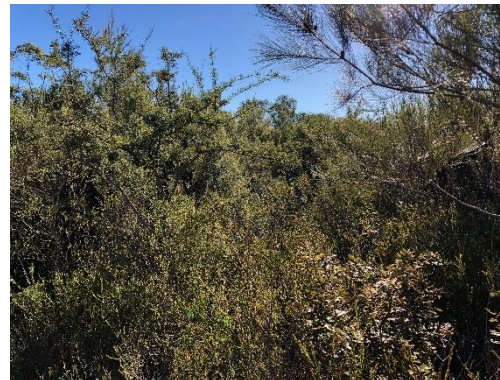
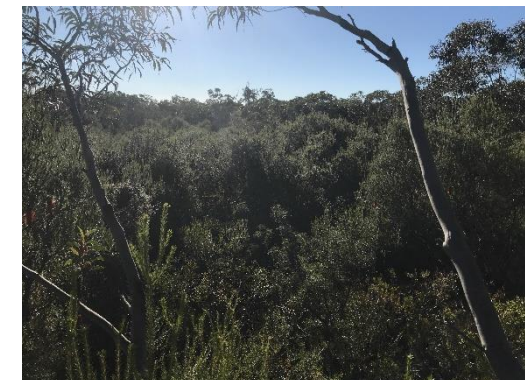
## Swamp 91

- Swamp 91 is a small oval-shaped swamp located over Longwall 315.
- This swamp was previously mapped as Sedgeland-heath Complex (BBS 2008). Field inspections identified that the extent of swamp vegetation is reduced in area and conforms to Banksia Thicket with the adjoining vegetation identified as Sandstone Heath Woodland. Swamp 91 is located south of Fire Road 9E

- Swamp 91 lacks a terminal step.
